# Inner Basin Pipeline & Waterline Road **Reconstruction & Relocation Project**

October 25, 2012

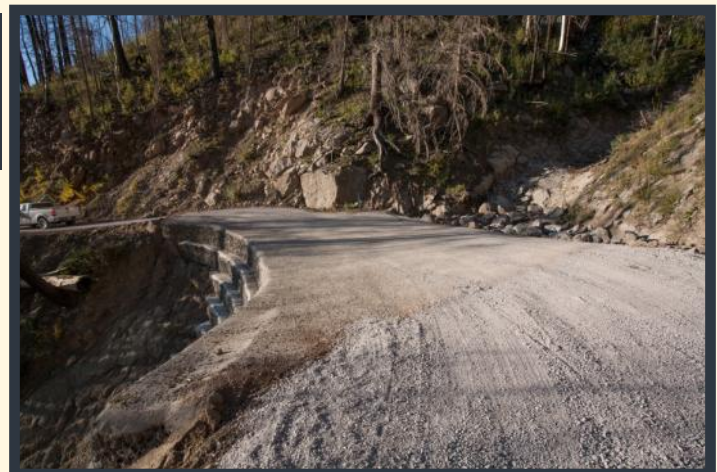
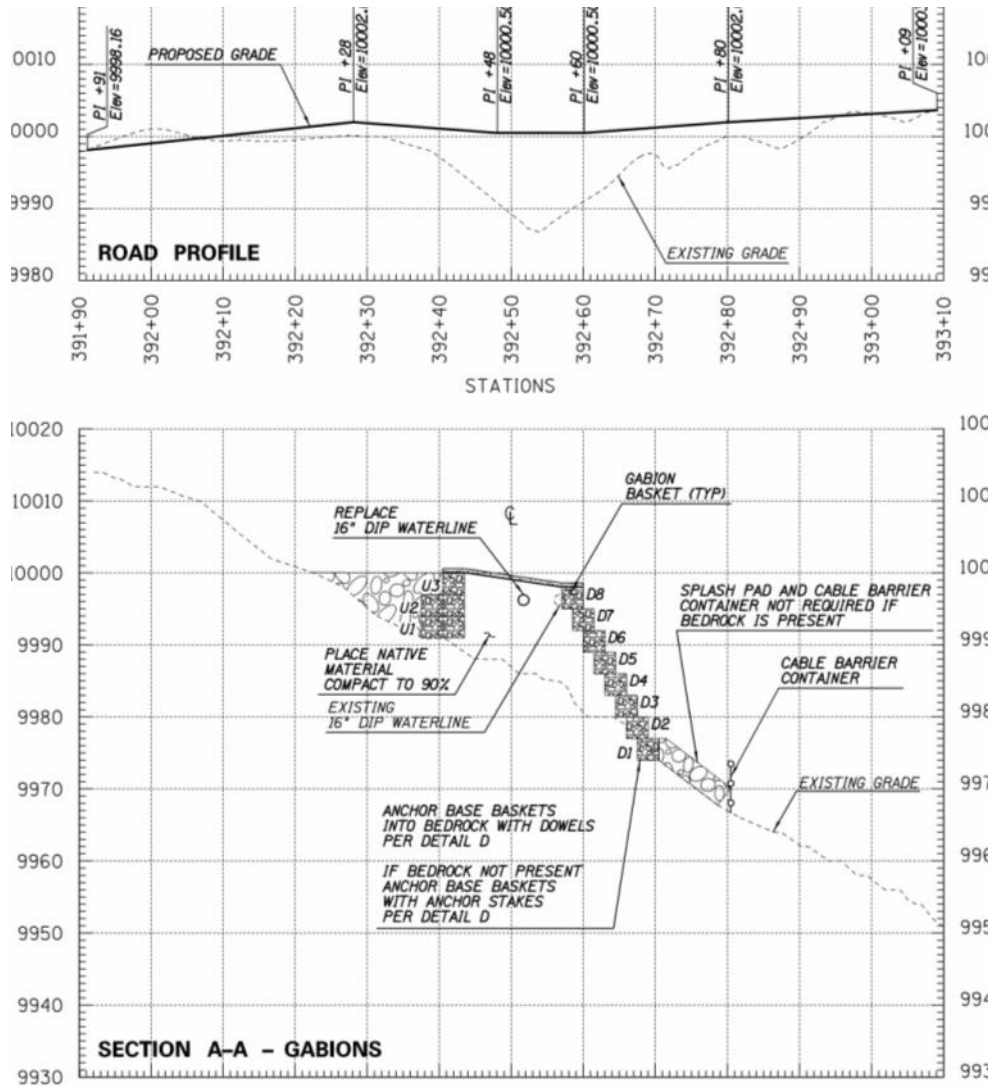
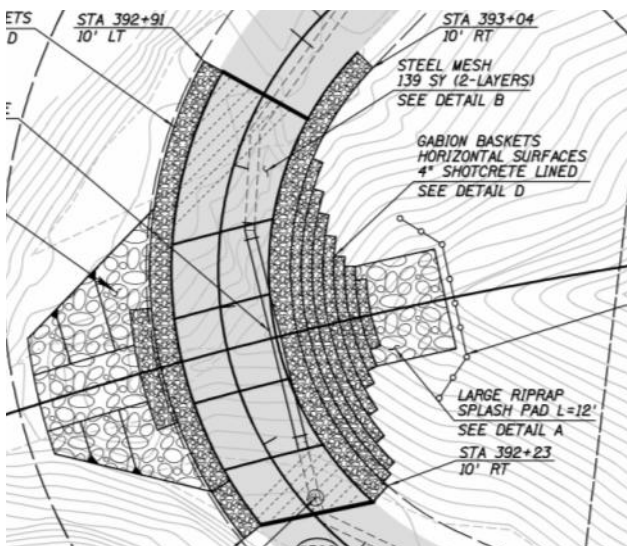
# Site 2

### SITE 2 DAMAGE ASSESSMENT

**Damage Assessment:** Very Severe  
**Nature of Damage:** Erosion at a natural inside drainage at a major valley or ravine  
**Pipe Condition:** 40 feet of 16-inch DIP lost and missing, another 19 feet exposed  
**Lost Material:** About 1,850 cu yds  
**Mass Wasting Character:** Flowing rock and larger trees and vegetation  
**Hunter/Jacobs Mitigation Design:** Upstream/Downstream Crossing Repair

Site 2 is located in the bend of the road at a major valley or ravine location. Stormwater runoff has traditionally passed over the access road and continued downstream in the ravine. With the event of the Schultz Fire, runoff rates have nearly doubled and upstream debris both in the form of flowing rock as well as large trees and uprooted vegetation are flowing down the valley. The flowline has reached equilibrium grade as much of the ravine has been lowered to the bedrock elevation, nearly 25 feet lower than the pre-fire drainageway profile. Loss of cover material up slope and down slope resulted in the exposure of bedrock.

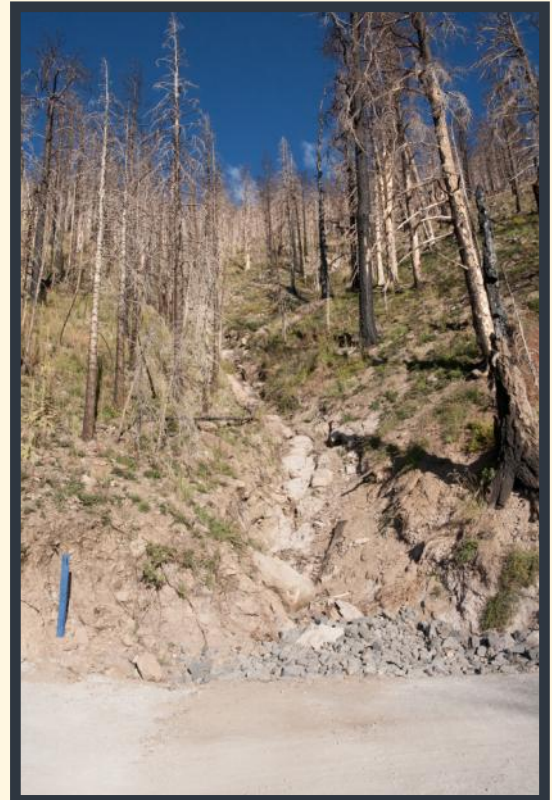
### SITE 4 FINAL CONSTRUCTION

Completed road crossing (above), and view looking up-gradient (right), September 27, 2012. Photo: Tom Alexander Photography

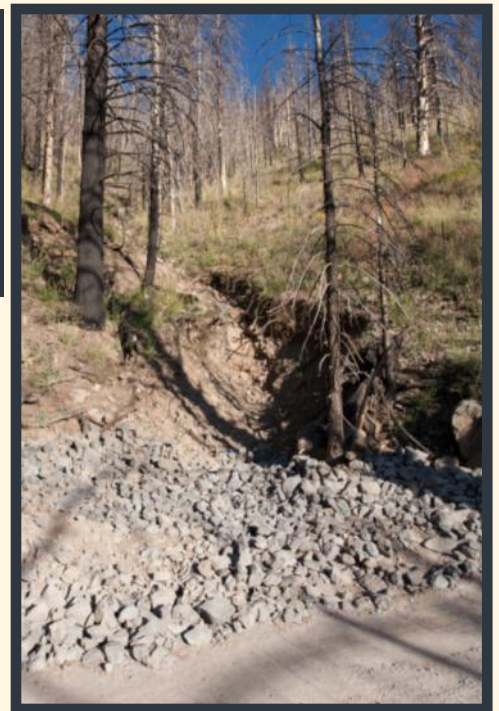
### SITE 5 FINAL CONSTRUCTION

Completed road crossing (above), view looking down-gradient (left) and up-gradient (right), September 27, 2012. Photo: Tom Alexander Photography

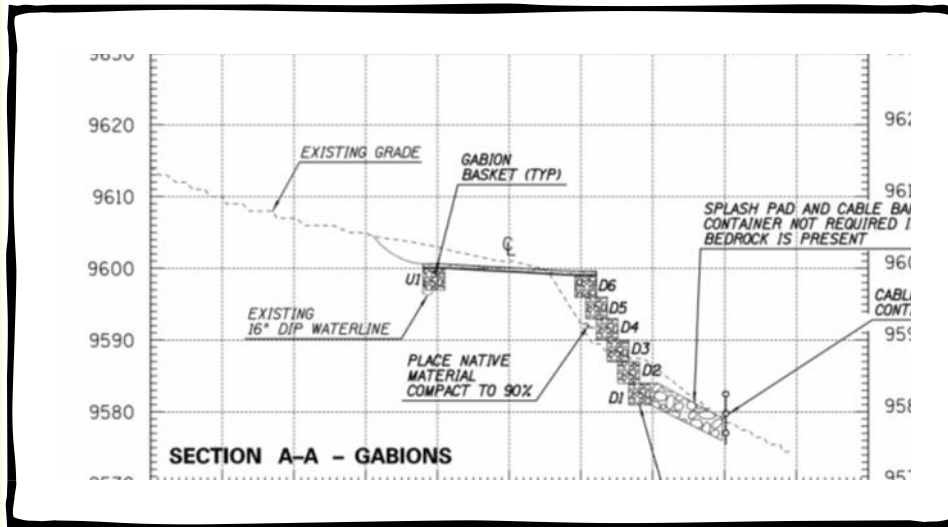
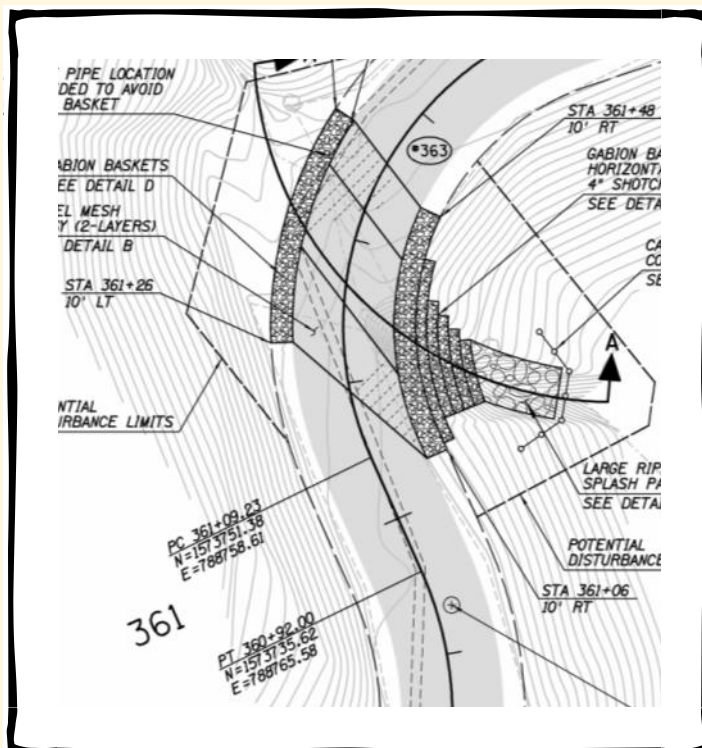
# Site 5

## SITE 5 DAMAGE ASSESSMENT

**Damage Assessment:** Severe

**Nature of Damage:** Erosion of a natural inside drainage area at a major valley location

**Pipe Condition:** 70 feet of 16-inch DIP exposed and still in place

Site 5 is located in the bend of the road at a major valley location. Stormwater runoff has traditionally gone over the access road and downstream following the ravine. With the event of the Schultz Fire, runoff rates have nearly doubled, and upstream debris in the form of displaced soil and flowing rock has been deposited on the roadway. On the outside edge of the access road, the embankment and sideslopes have experienced significant erosion and rutting. Upstream, the runoff had eroded to bedrock. Downstream, runoff continues to erode the downstream soils to a point of equilibrium that has yet to be achieved.

**Hunter/Jacobs Mitigation Design:** Minor Drainage Crossing Repair

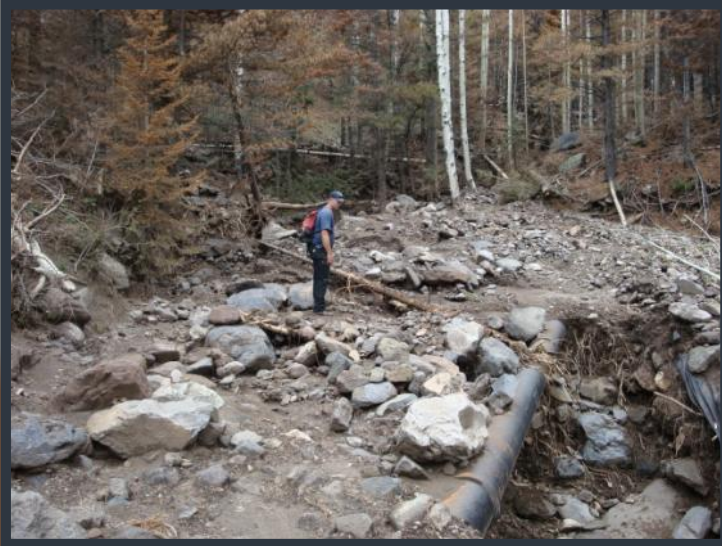
## SITE 7 AFTER FIRST MAJOR MONSOON EVENT

View of drainage crossing and exposed 16-inch DIP, August 4, 2010. Photo: City of Flagstaff, Utilities Division

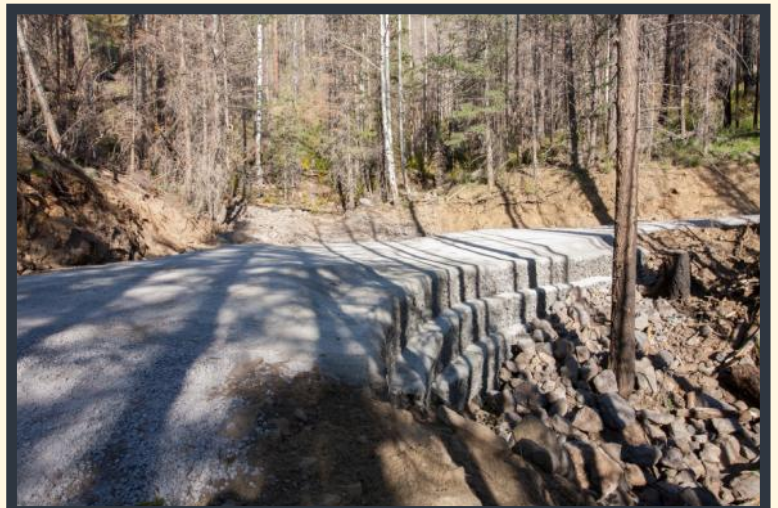
## SITE 7 POST-MONSOON

View looking down-gradient from road crossing, September 9, 2010. Photo: FEMA

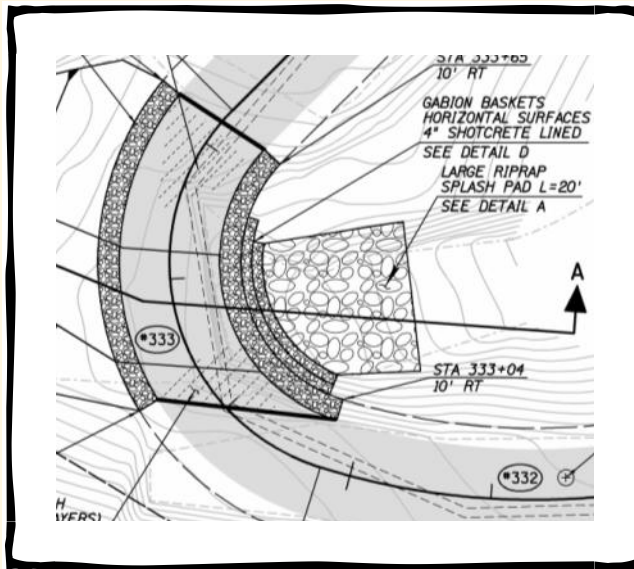
## SITE 9 DAMAGE ASSESSMENT

**Damage Assessment:** Severe

**Nature of Damage:** Upslope debris flow at major valley location

**Pipe Condition:** 16-inch DIP exposed but partially embedded for about 30 feet

Similar in geometry and the impacts, due to erosion, as Site 7, Site 9 is located in the bend of the road at a major valley location. The pipeline itself is acting as a grade control structure that is preventing further upstream erosion, but has resulted in significant downstream erosion. Downstream, runoff continues to erode the downstream soils to find a point of equilibrium that has yet to be achieved. On the outside edge of the access road, the embankment and sideslopes have experienced significant erosion and rutting.

**Hunter/Jacobs Mitigation Design:** Minor Drainage Crossing Repair

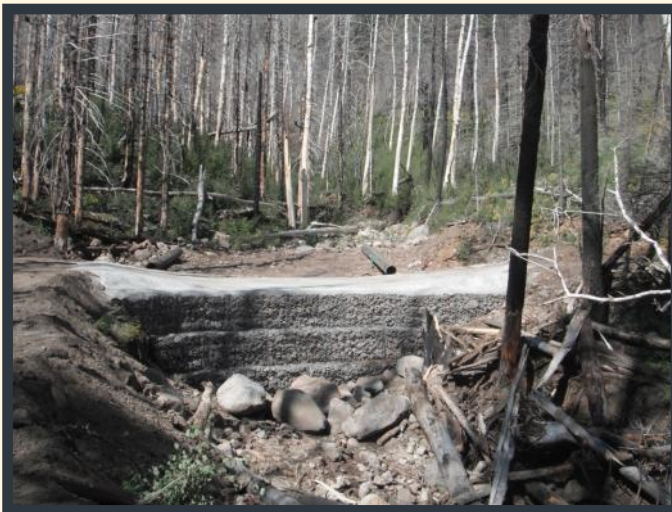
## SITE 9 AFTER FIRST MONSOON EVENT

Drainage crossing and exposed 16-inch DIP, August 4, 2010. Photo: City of Flagstaff, Utilities Division

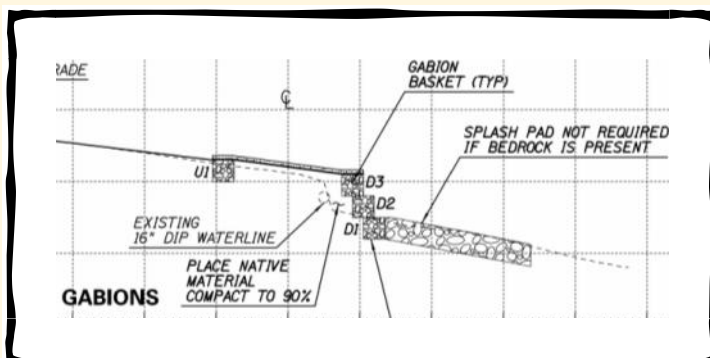
## SITE 9 FINAL CONSTRUCTION

Road crossing and gabion structure, September 6, 2012. Photo: Erin Young, Fluid Solutions

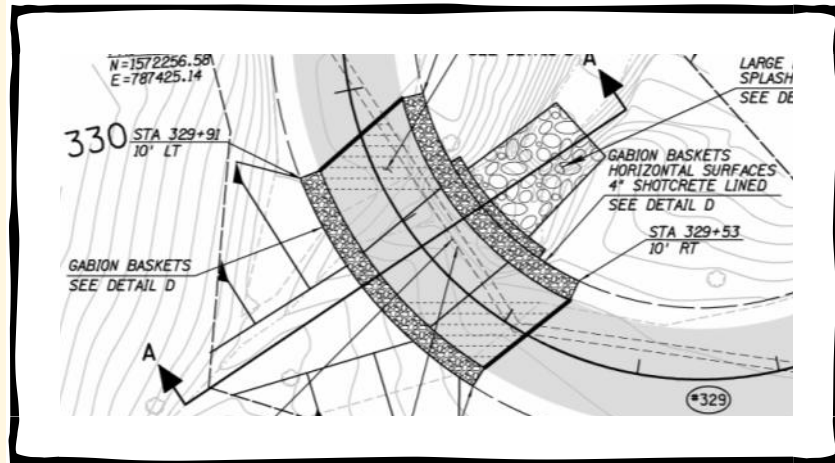
## SITE 11 DAMAGE ASSESSMENT

**Damage Assessment:** Moderate

**Nature of Damage:** Debris and loss of cover material at relatively flat drainage ravine

**Pipe Condition:** 20 feet of 16-inch DIP exposed and still in place

While this particular ravine is relatively flat compared to many of the drainageways being crossed, there is still enough erosion to expose the pipe and erode away some of the existing roadway section. While not as deep as some of the other repair sites, there is still downstream erosion that must be repaired and armored to prevent further damage to the pipe in the future. Upstream of the exposure site there is deposition of materials in the roadway that was removed.

**Hunter/Jacobs Mitigation Design:**

Minor Drainage Crossing Repair

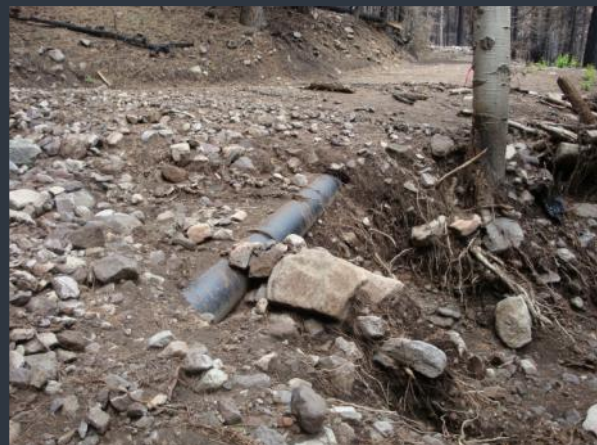
## SITE 11 FINAL CONSTRUCTION

Completed road crossing, September 27, 2012. Photo: Tom Alexander Photography

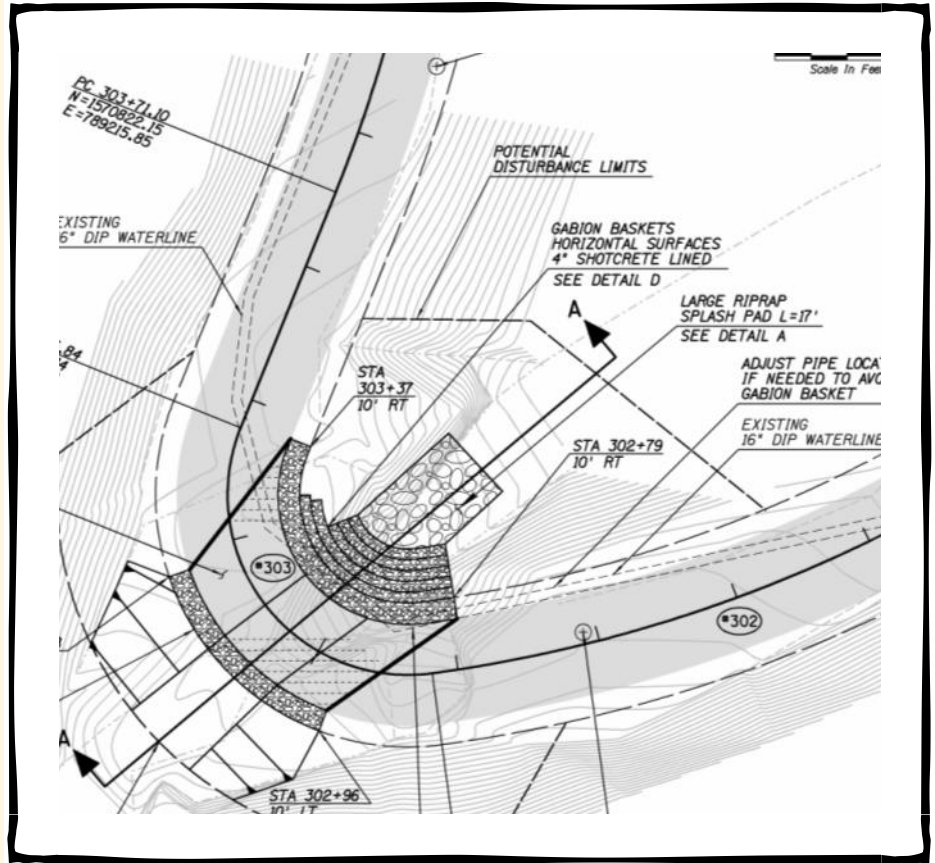
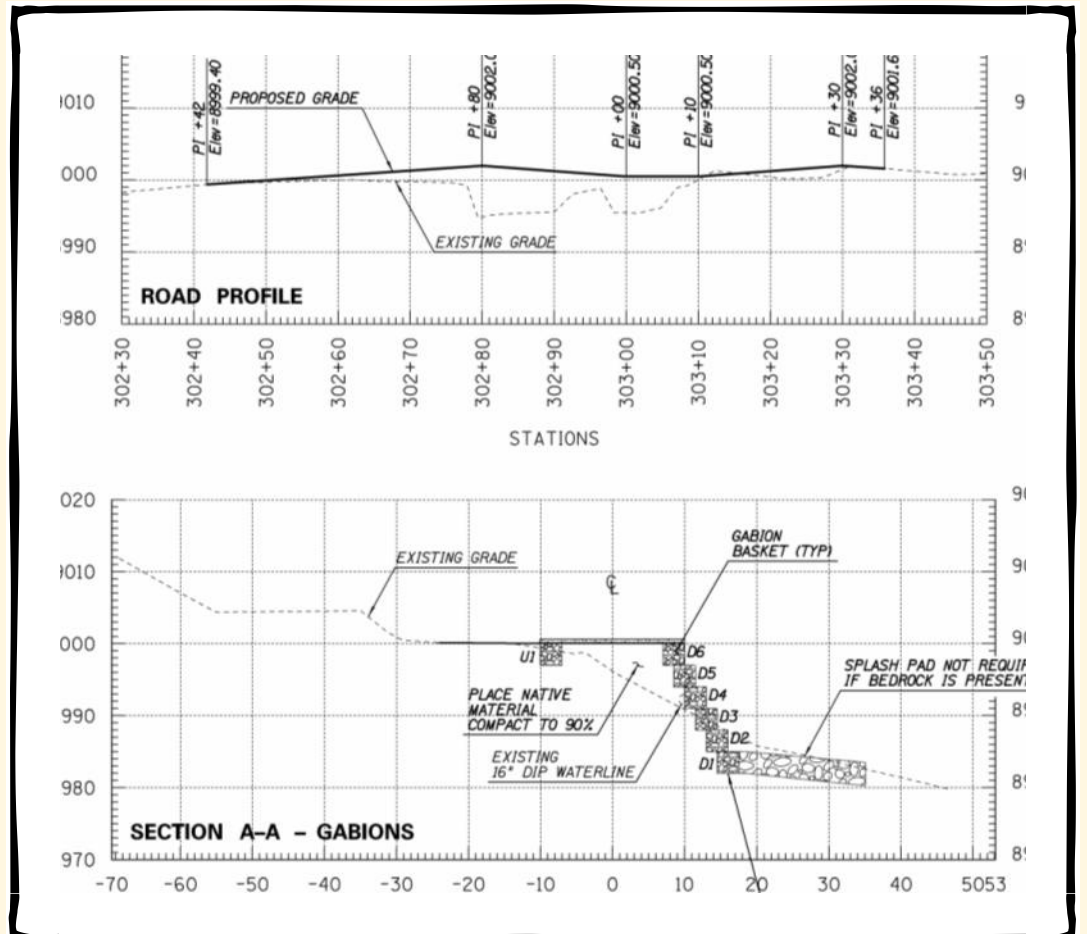
# Site 14

## SITE 14 DAMAGE ASSESSMENT

**Damage Assessment:** Severe  
**Nature of Damage:** Erosion and loss of cover material at a natural inside drainage area at a major valley location

**Pipe Condition:** 40 feet of 16-inch DIP exposed and still in place

Similar in geometry with slightly more severe erosion conditions than Site 7, Site 14 is located in the bend of the road at a major valley location. The access road embankment has eroded away down to near bedrock, the embankment and sideslopes have experienced significant erosion and rutting. This site has minimal loss of cover upslope and more severe erosion to bedrock downslope. Upstream debris in the form of displaced soil and flowing rock are depositing at the upstream segment of this crossing. The pipeline itself for a period of time was acting as a grade control structure that was preventing further upstream erosion. The headcutting undermined the materials around the pipe and continued to erode upstream of the pipe itself, leaving the pipe exposed above existing ground.

**Hunter/Jacobs Mitigation Design:** Upstream/Downstream Crossing Repair

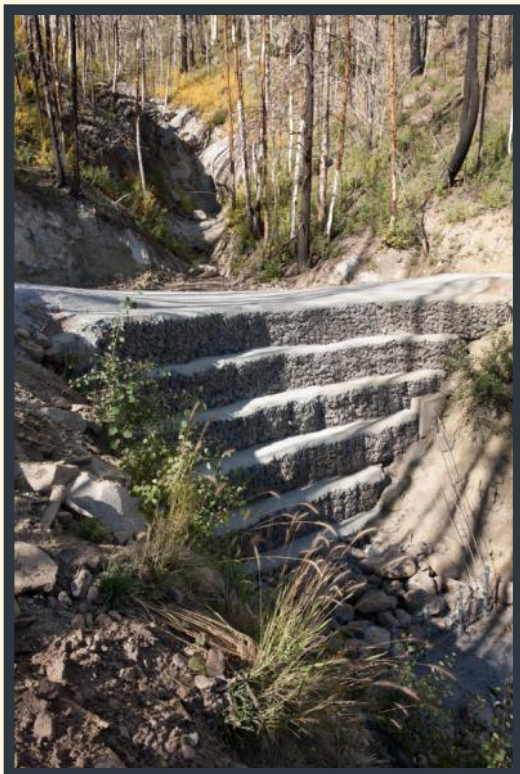
## SITE 15 POST-MONSOON

Similar in geometry with and erosion to the conditions of the previous Site 14, Site 15 is located in the bend of the road at a major valley location. The pipeline itself for a period of time was apparently acting as a grade control structure that was preventing further upstream erosion. Ultimately, the headcutting undermined the materials around the pipe and continued to erode upstream of the pipe crossing itself, leaving the pipe exposed above the existing ground. The access road embankment has eroded away down to near bedrock and the embankment and sideslopes have experienced significant erosion and rutting. Runoff continues to erode downstream soils to find a point of equilibrium that has yet to be achieved, but is still very rocky in nature.

**Damage Assessment:** Severe

**Nature of Damage:** Erosion of a natural inside drainage area at major valley location

**Pipe Condition:** 40 feet of 16-inch DIP exposed and suspended but still in place

**Mass Wasting Character:** Up-slope aggregate debris flow to bedrock

View looking at drainage crossing and suspended 16-inch DIP, September 9, 2010. Photo: FEMA

**Hunter/Jacobs Mitigation Design:** Upstream/Downstream Crossing Repair

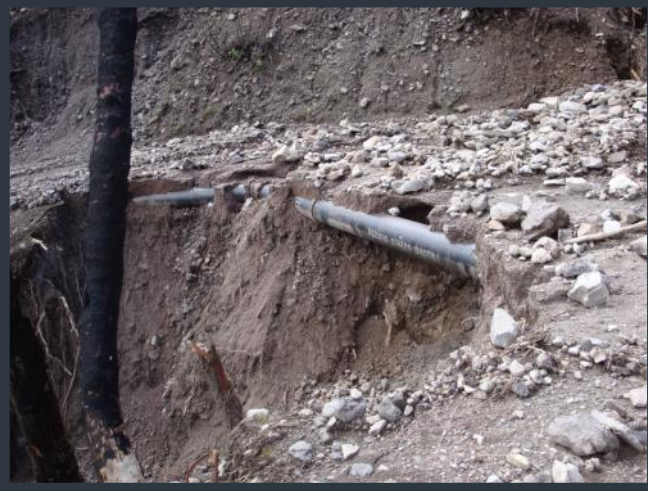
## SITE 16 AFTER FIRST MAJOR MONSOON EVENT

**Damage Assessment:** Severe

**Nature of Damage:** Severe erosion at a natural inside drainage at a major valley location

**Pipe Condition:** 40 feet of 16-inch DIP exposed and partially embedded but still in place

Similar in geometry with and erosion to the conditions of the previous Site 15, Site 16 is located in the bend of the road at a major valley location. On the down slope side of the DIP, there is a severe cut/drop that on Sept 9, 2010 measured approximately 30 feet deep and approximately 70 feet down slope and about 40 feet wide. Upstream debris in the form of displaced soil and flowing rock are depositing at the upstream segment of this crossing. Over time this drainageway has apparently gained elevation by depositing materials over the bedrock and raising the grade of the entire drainage ravine. The flows through the site are now resulting in heavy headcutting from the downstream erosion. The headcutting undermined the materials around the pipe, leaving the pipe exposed above the existing ground. The access road embankment and sideslopes have experienced significant erosion and rutting.

View looking at drainage crossing and exposed 16-inch DIP on August 4, 2010. City of Flagstaff, Utilities Division

**Hunter/Jacobs Mitigation Design:** Upstream/Downstream Crossing Repair

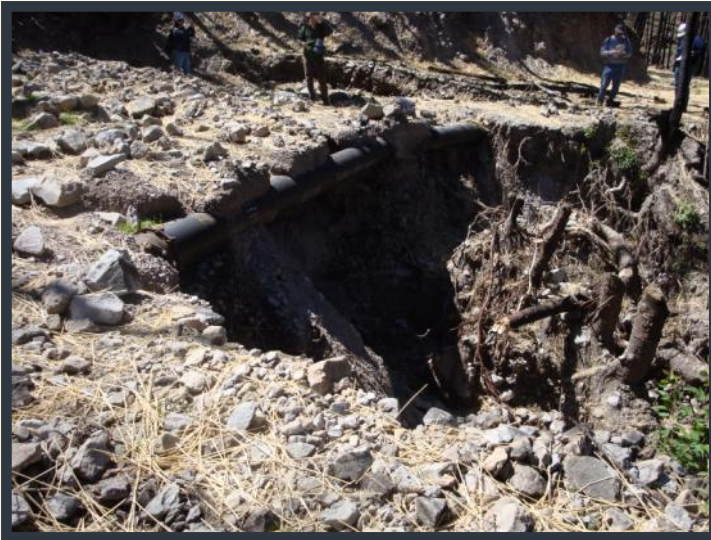
## SITE 16 POST-MONSOON

View looking at drainage crossing and exposed pipe, September 9, 2010. Photo: FEMA

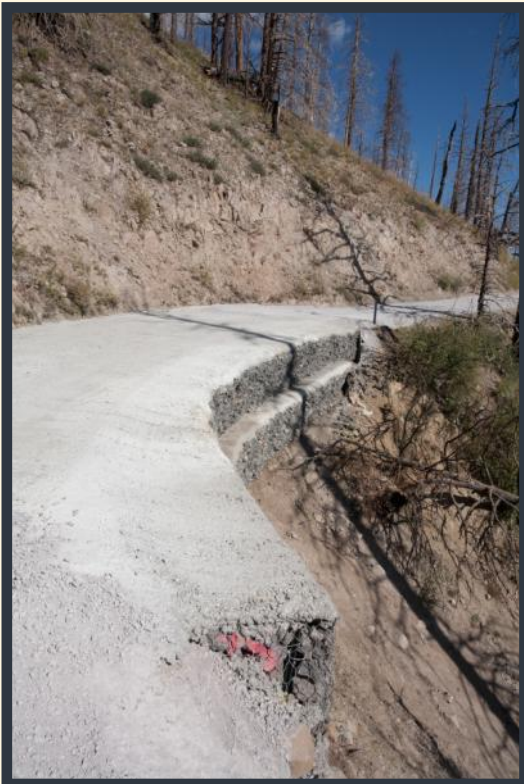
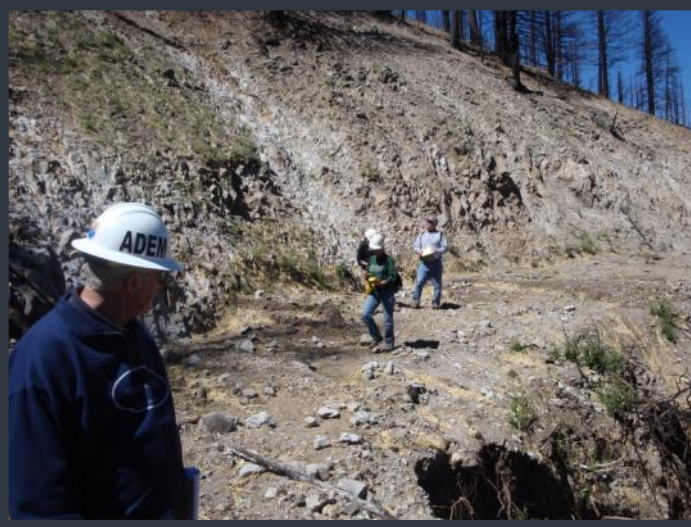
## SITE 18 POST-MONSOON & FINAL CONSTRUCTION

**Damage Assessment:** Moderate

**Nature of Damage:** Sheetflow at moderate bend in road where minor depression upstream concentrates flows

**Lost Material:** About 332 cu yds, including damage down the road

**Mass Wasting Character:** Sheet flow, granular backfill and large rip rap type material. Erosion to bedrock downstream of crossing.

Site 18 is located at a moderate bend in the access road where there is a minor depression in the upstream topography to concentrate the upstream flows to this location. The embankment and sideslopes are experiencing significant erosion resulting in the reduction of the access road and supporting embankment. The runoff continues to erode the downstream soils to find a point of equilibrium that has yet to be achieved, but left alone, will headcut through the access road and expose the pipeline.

(Above) Damage to road and to outside edge of road, September 9, 2010. Photo: FEMA

**Hunter/Jacobs Mitigation Design:** Minor Drainage Crossing Repair

(Left) Completed road crossing, September 27, 2012. Photo: Tom Alexander Photography

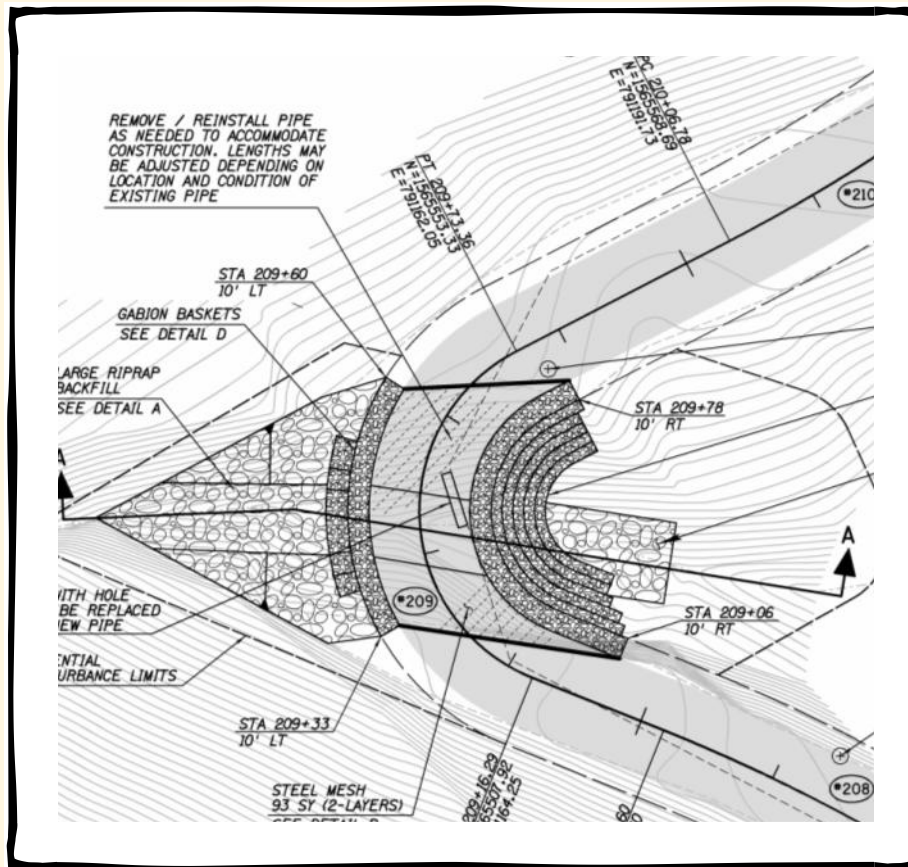
## SITE 22 POST-MONSOON

This site has sustained very severe damage in terms of erosion. Stormwater runoff has traditionally gone over the access road and downstream following the ravine. With the event of the Schultz Fire, runoff values have nearly doubled, and upstream debris in the form of flowing rock as well as large trees and uprooted vegetation are "flowing" down the valley. The flowline has reached an equilibrium grade as much of the ravine has been lowered to be either at or near the bedrock elevation, nearly 20 feet lower than the pre-fire drainageway profile.

Exposed 16-inch DIP at drainage crossing, September 9, 2010. Photo: FEMA

**Damage Assessment:** Very Severe

**Nature of Damage:** Erosion at a natural inside drainage at a major valley or ravine location

**Pipe Condition:** 50 feet of DIP exposed and suspended; one joint of DIP had a 3-inch hole in the top of the barrel

**Hunter/Jacobs Mitigation Design:** Upstream/Downstream Crossing Repair

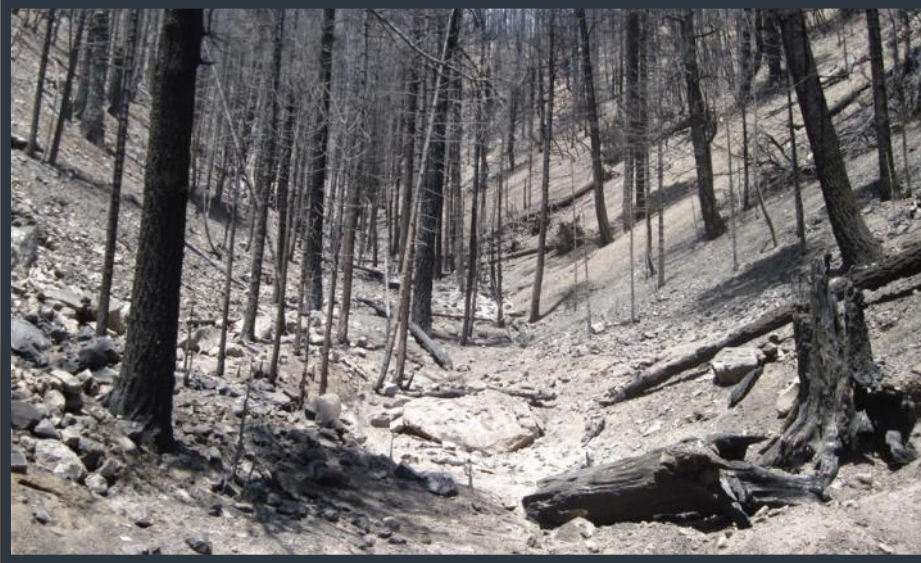
## SITE 14 POST-FIRE & PRE-MONSOON

View looking up drainage crossing on July 7, 2010, prior to the onset of the monsoon. Notice the slight depression (swale) of the drainage with no defined channel bottom in comparison with the photograph by FEMA on the adjacent page. The tree stump (in foreground of this photo) serves as a marker to compare the amount of debris that filled the drainage. Photo: Utilities Division, City of Flagstaff

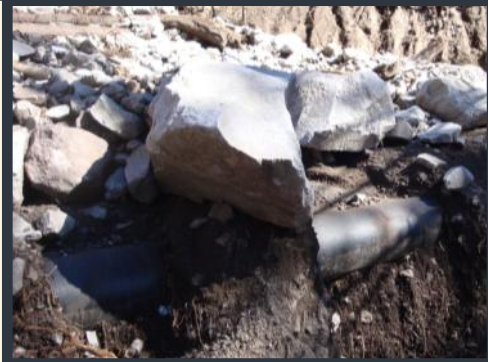
## SITE 24 POST-MONSOON

**Damage Assessment:** Severe  
**Nature of Damage:** Loss of cover material where bend occurs in road at major valley location  
**Pipe Condition:** 30-feet of 16-inch DIP exposed  
**Lost Material:** About 1,850 cu yds  
**Mass Wasting Character:** Displaced soil and flowing rock  
**Hunter/Jacobs Mitigation Design:** Minor Drainage Crossing Repair

This is a 100-foot wide rocky channel with gentle gradients up and down slope (20% grade). The upslope was level with the top of the DIP, however, downslope of the DIP was an 8-foot cut that continued downslope for about 50 feet. The pipeline itself was acting as a grade control structure that was preventing further upstream erosion, but had resulted in downstream erosion. Upstream debris in the form of displaced soil and flowing rock has deposited upstream of the crossing. On the outside edge of the access road, the embankment and sideslopes have experienced significant erosion and rutting. Runoff continues to erode the downstream soils to find a point of equilibrium that has yet to be achieved, but is still very rocky in nature.

View looking at drainage crossing on September 9, 2010. Compare with photo on opposite page. Photo: FEMA

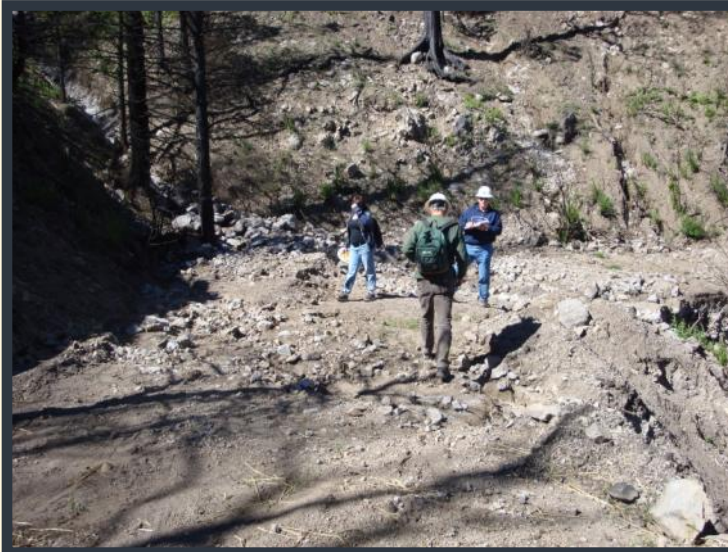
## SITE 25 POST-MONSOON

No pipe was exposed at this site following the monsoon rains, September 9, 2010. Photo: FEMA

**Damage Assessment:** Moderate

**Nature of Damage:** Erosion over the inside curve and downslope at a major valley location

**Hunter/Jacobs Mitigation Design:** Minor Drainage Crossing Repair

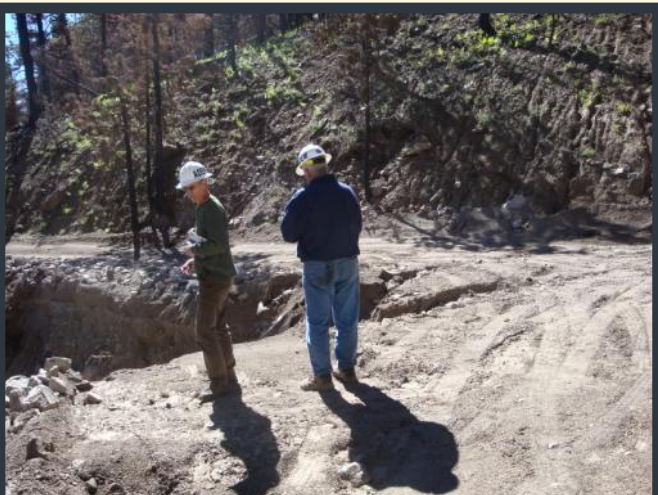
## SITE 26 POST-MONSOON

**Damage Assessment:** Moderate

**Nature of Damage:** Erosion of inside curve and downslope at a major valley location

The grade of the drainage is fairly flat upstream of the roadway, but steep downstream. The roadway appears to have been acting as a form of grade control structure for the stream. Upstream debris in the form of displaced soil and flowing rock are depositing at the upstream segment of this crossing. Downstream, the embankment and sideslopes have experienced significant erosion and rutting. Runoff continues to erode the downstream soils to find a point of equilibrium that has yet to be achieved, but is still

Erosion and rutting of the road surface with heavy erosion downstream, September 9, 2010. Photo: FEMA

**Hunter/Jacobs Mitigation Design:** Minor Drainage Crossing Repair
